# Manhole Inspection Summary

Manhole # S25MM1003MH

Insp Date: **11/6/06 10:28 AM**

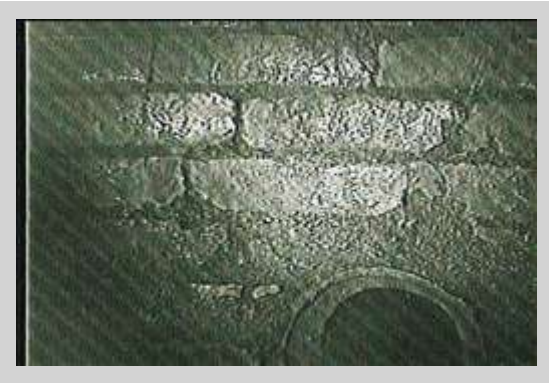
### 8 in. Circular Gravity Sewer Pipe Out @ 12 O'Clock

Pipe Material: **Clay** ☐ Pipe Lined

Invert Depth: **13.44** (ft.) Flow Characteristics: **Slow**

Infiltration: **None** Pipe Seal Cond: **Unknown**

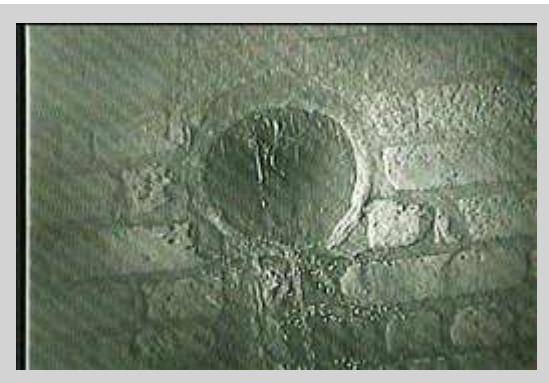
### 6 in. Circular Gravity Sewer Pipe In @ 6 O'Clock

Pipe Material: **Clay** ☐ Pipe Lined

Invert Depth: **7.96** (ft.) Flow Characteristics: **Slow**

Infiltration: **None** Pipe Seal Cond: **Unknown**

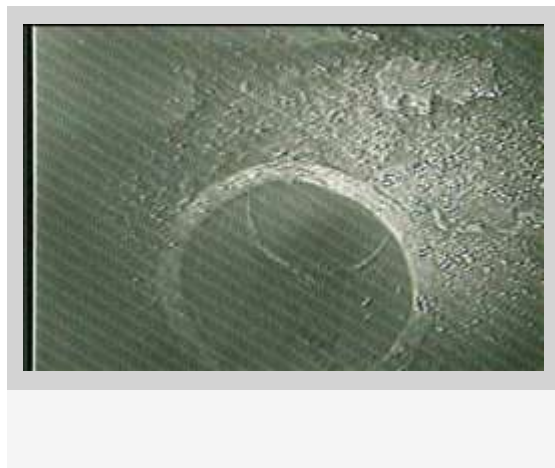
6 in. Circular Gravity Sewer

Pipe Material: **Clay**

Infiltration: **None**
